DEBRIS/ICE/TPS ASSESSMENT  
AND  
PHOTOGRAPHIC ANALYSIS  
OF  
SHUTTLE MISSION STS-32R

January 9, 1990

Gregory N. Katnik  
NASA/Kennedy Space Center  
TV-MSD-22

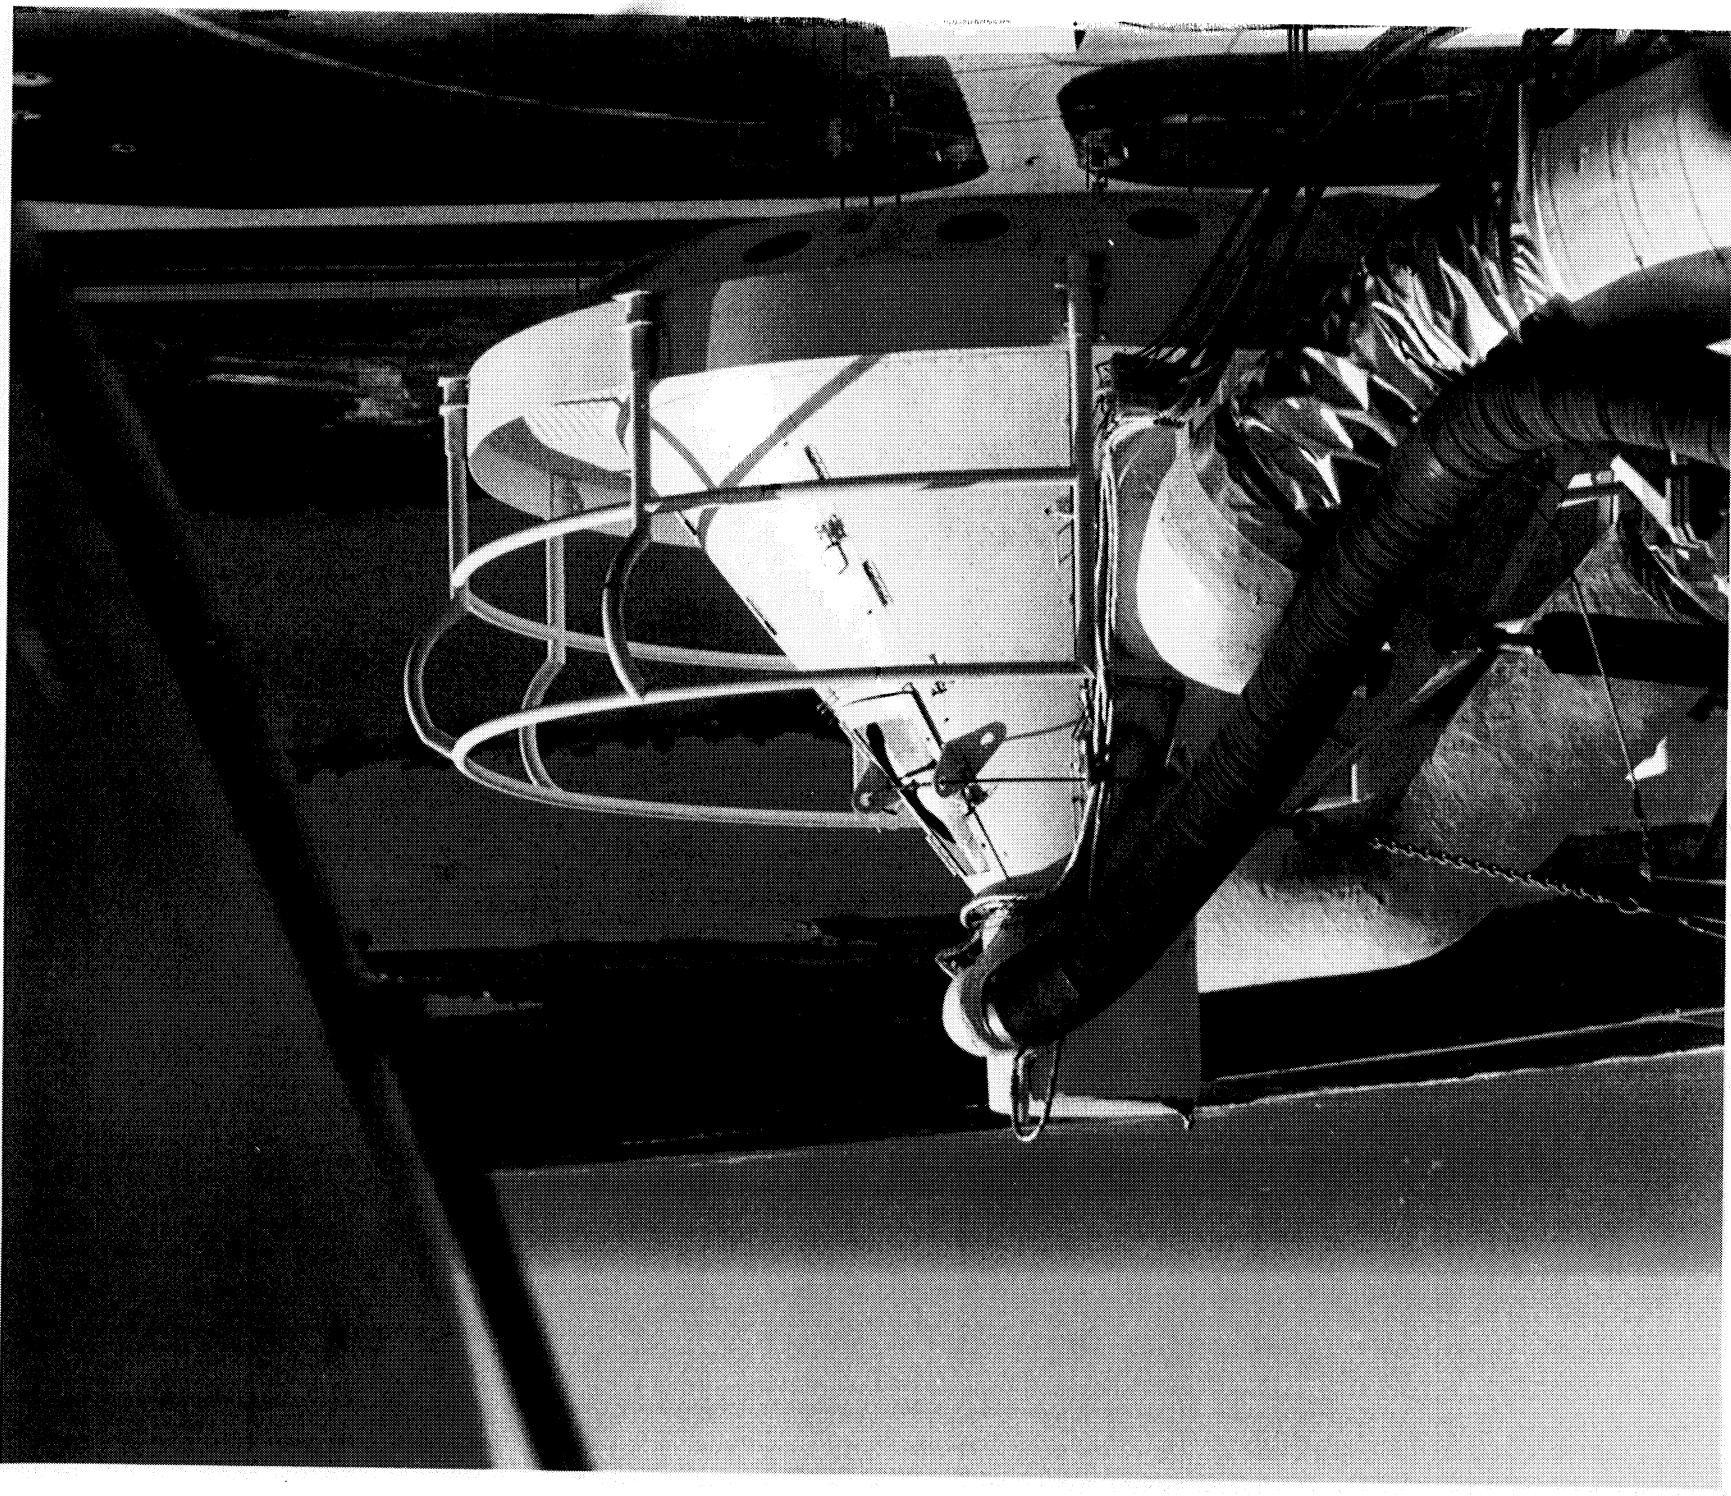
The GOX vent hood sustained launch damage in the form of a broken window and torn insulation on the plenum chamber

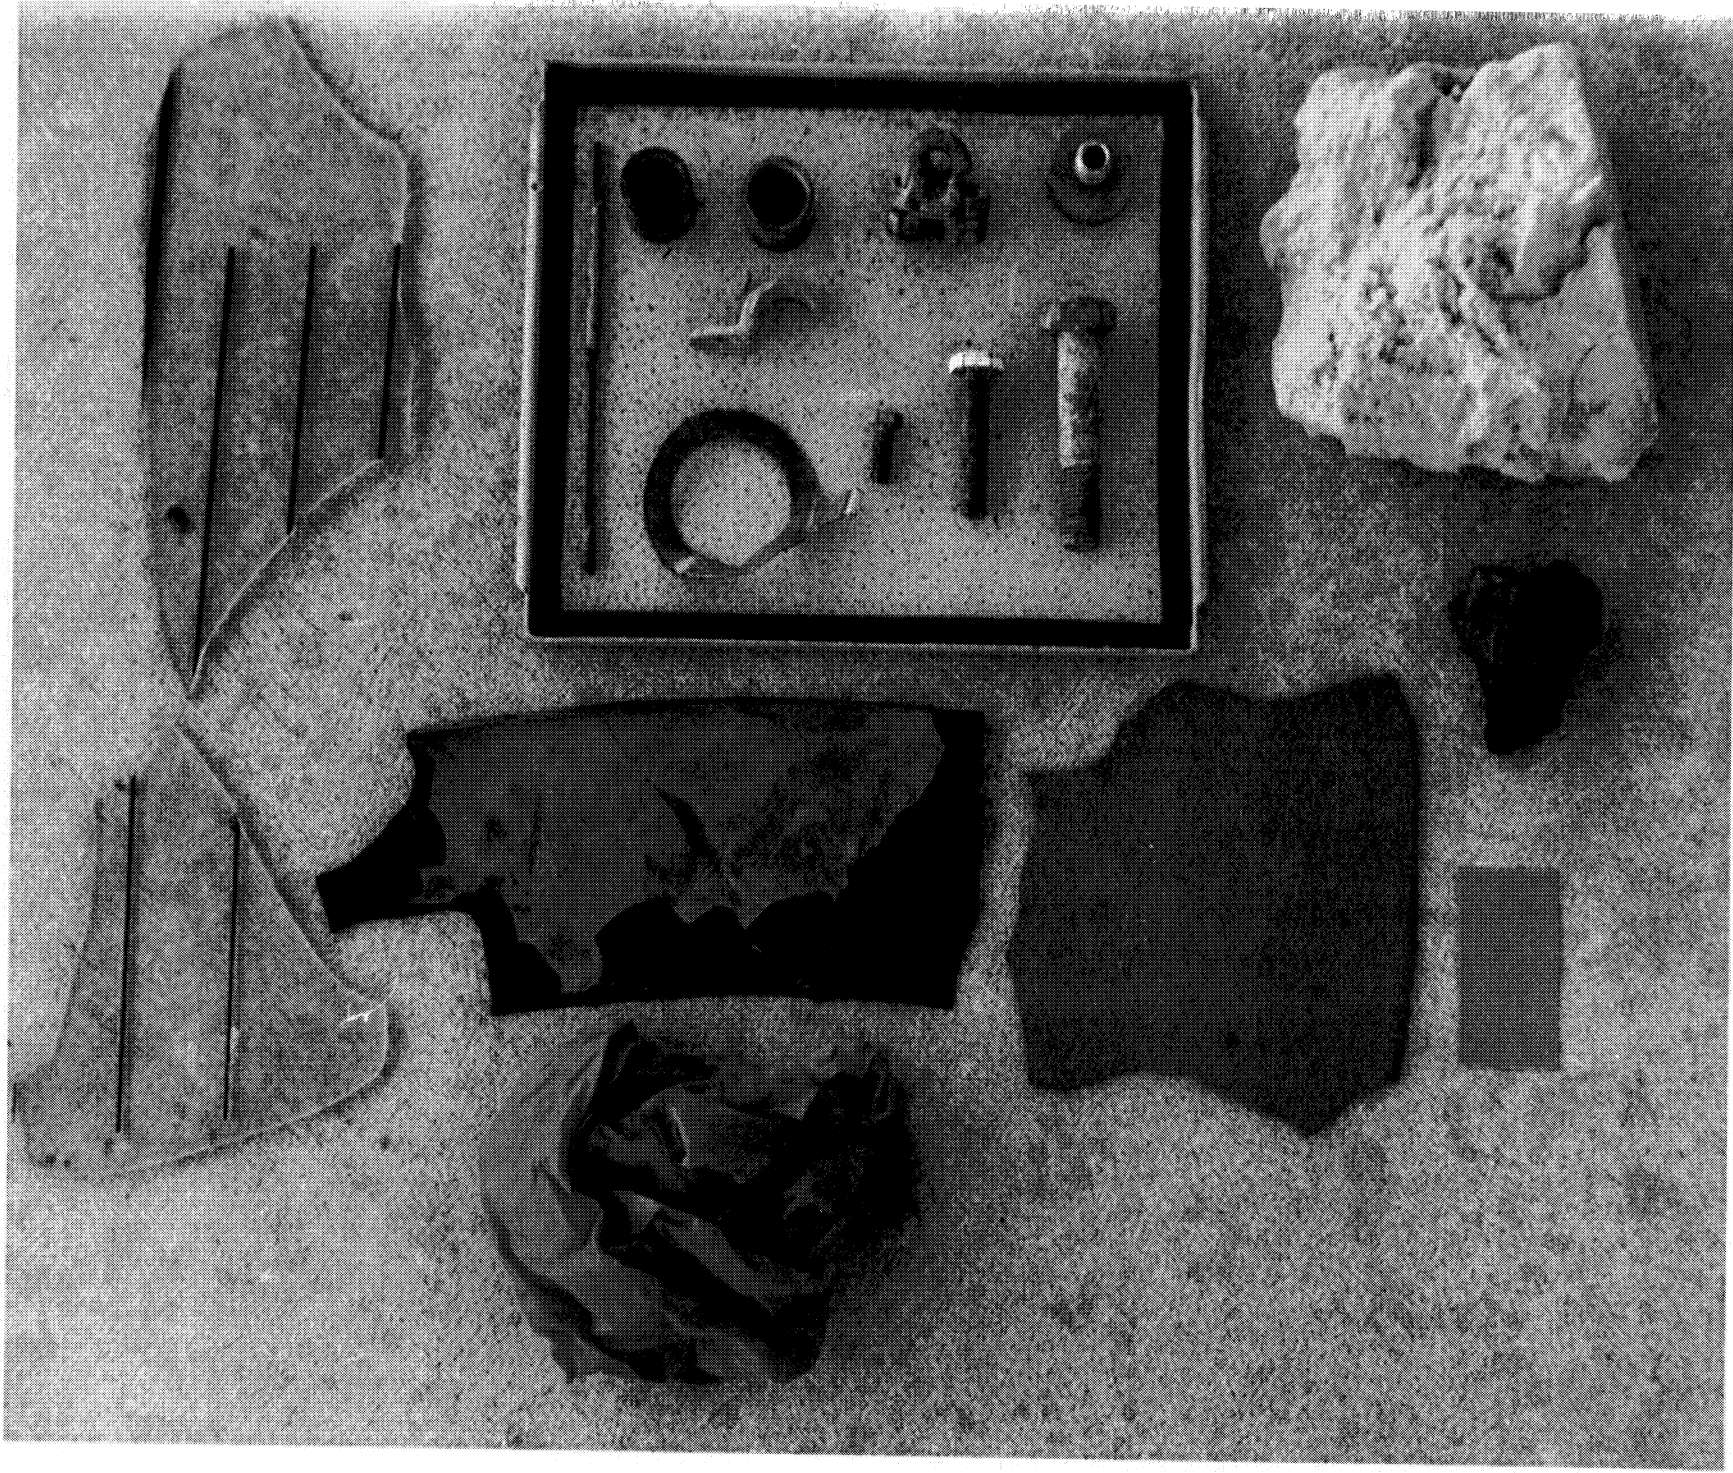
Typical debris recovered after launch. Note orange GSE tile  
shim and pieces of window from the GOX vent hood.

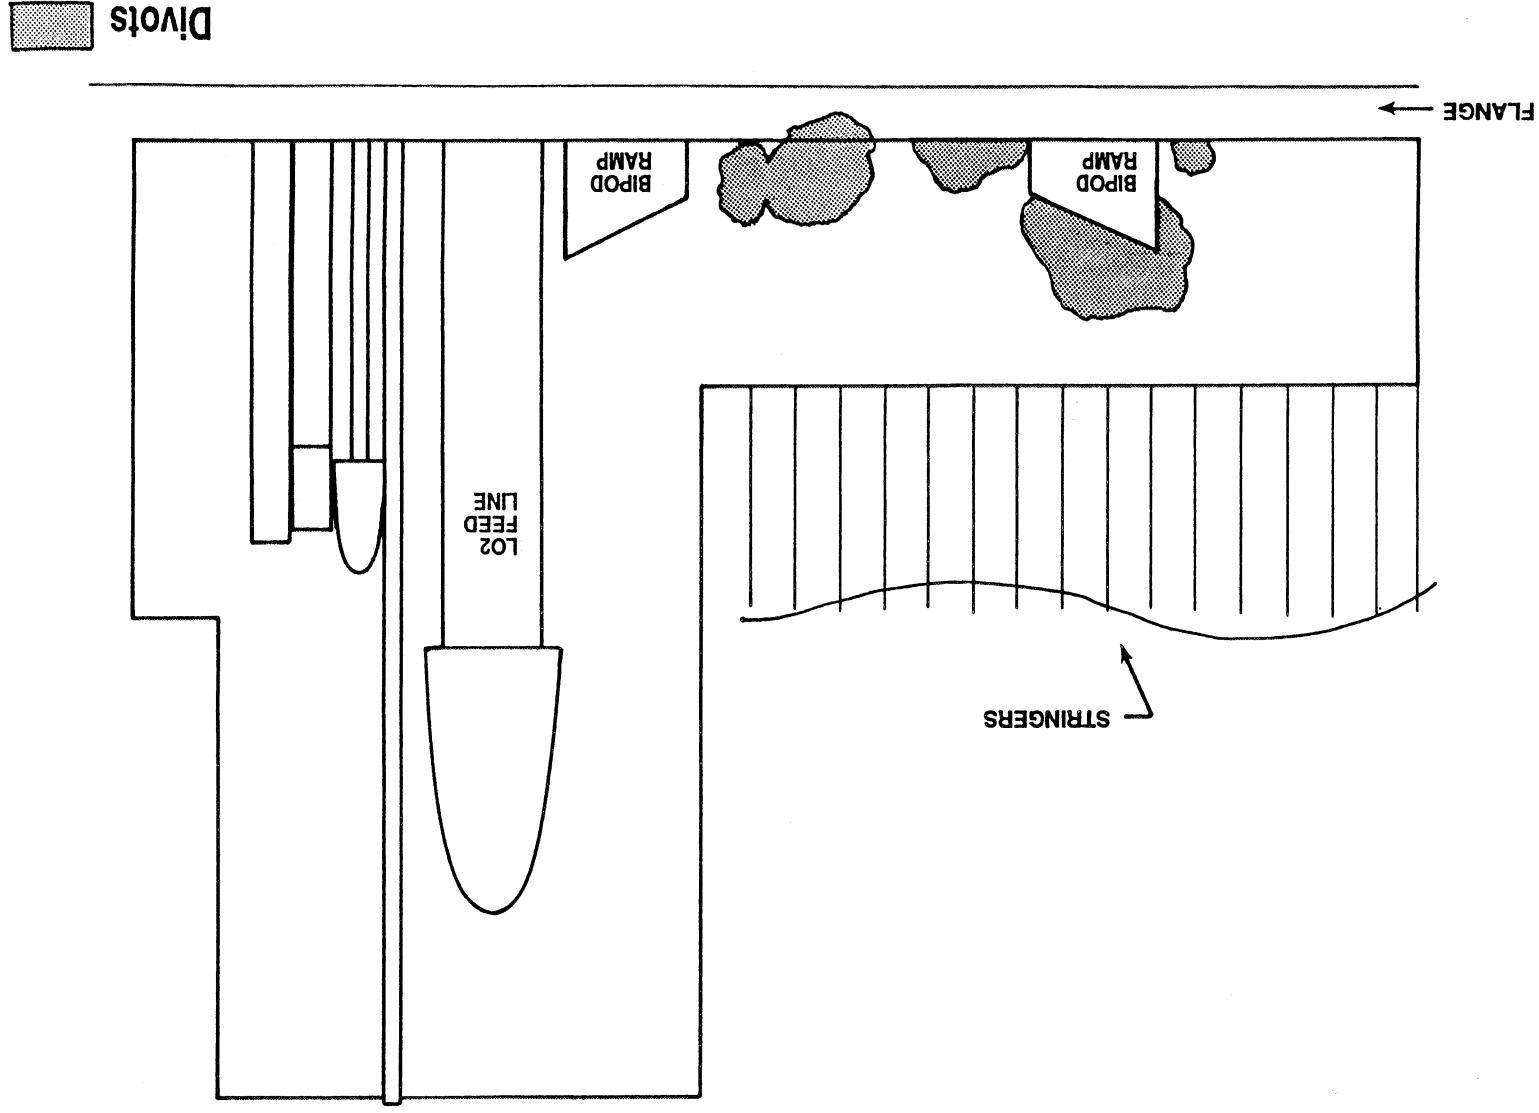
FIGURE 13. STS-32R IN-FLIGHT ANOMALY (STS-32-T-1)  
Missing Intertank TPS Shown on Post Separation Photos

One 35mm and two 16mm cameras in the ET/ORB umbilicals recorded SRB and ET separation. No anomalies were visible on the ogive or nosecone. The acreage of the intertank was intact except for five large divots in the area of the bipods (Figure 13). Two divots measuring 12-14 inches in diameter were located between the bipods and just above the intertank-to-LH2 tank flange. A third divot 14 inches in diameter was centered between the bipod ramps and extended into the intertank-to-LH2 tank flange. The largest divot, measuring 28 inches wide, surrounded the

forward part of the LH bipod ramp. Stringers were visible in the divots indicating a depth greater than the isochem line. A fifth divot measuring 6 inches in diameter was located outboard of the LH bipod ramp and just above the LH2 tank splice. The LH2 tank acreage was in good condition with the exception of 2 divots, one of which was a repair, in the spray abort areas. Four large pieces of ET TPS appeared from behind the umbilical cable tray or fell aft into the field of view. These foam pieces were the divots from the intertank area. The top of the LH2 umbilical was damaged and covered with frozen hydrogen. The LO2 umbilical was in good condition with the exception of ice or a thin layer of TPS peeled back on top of the umbilical.

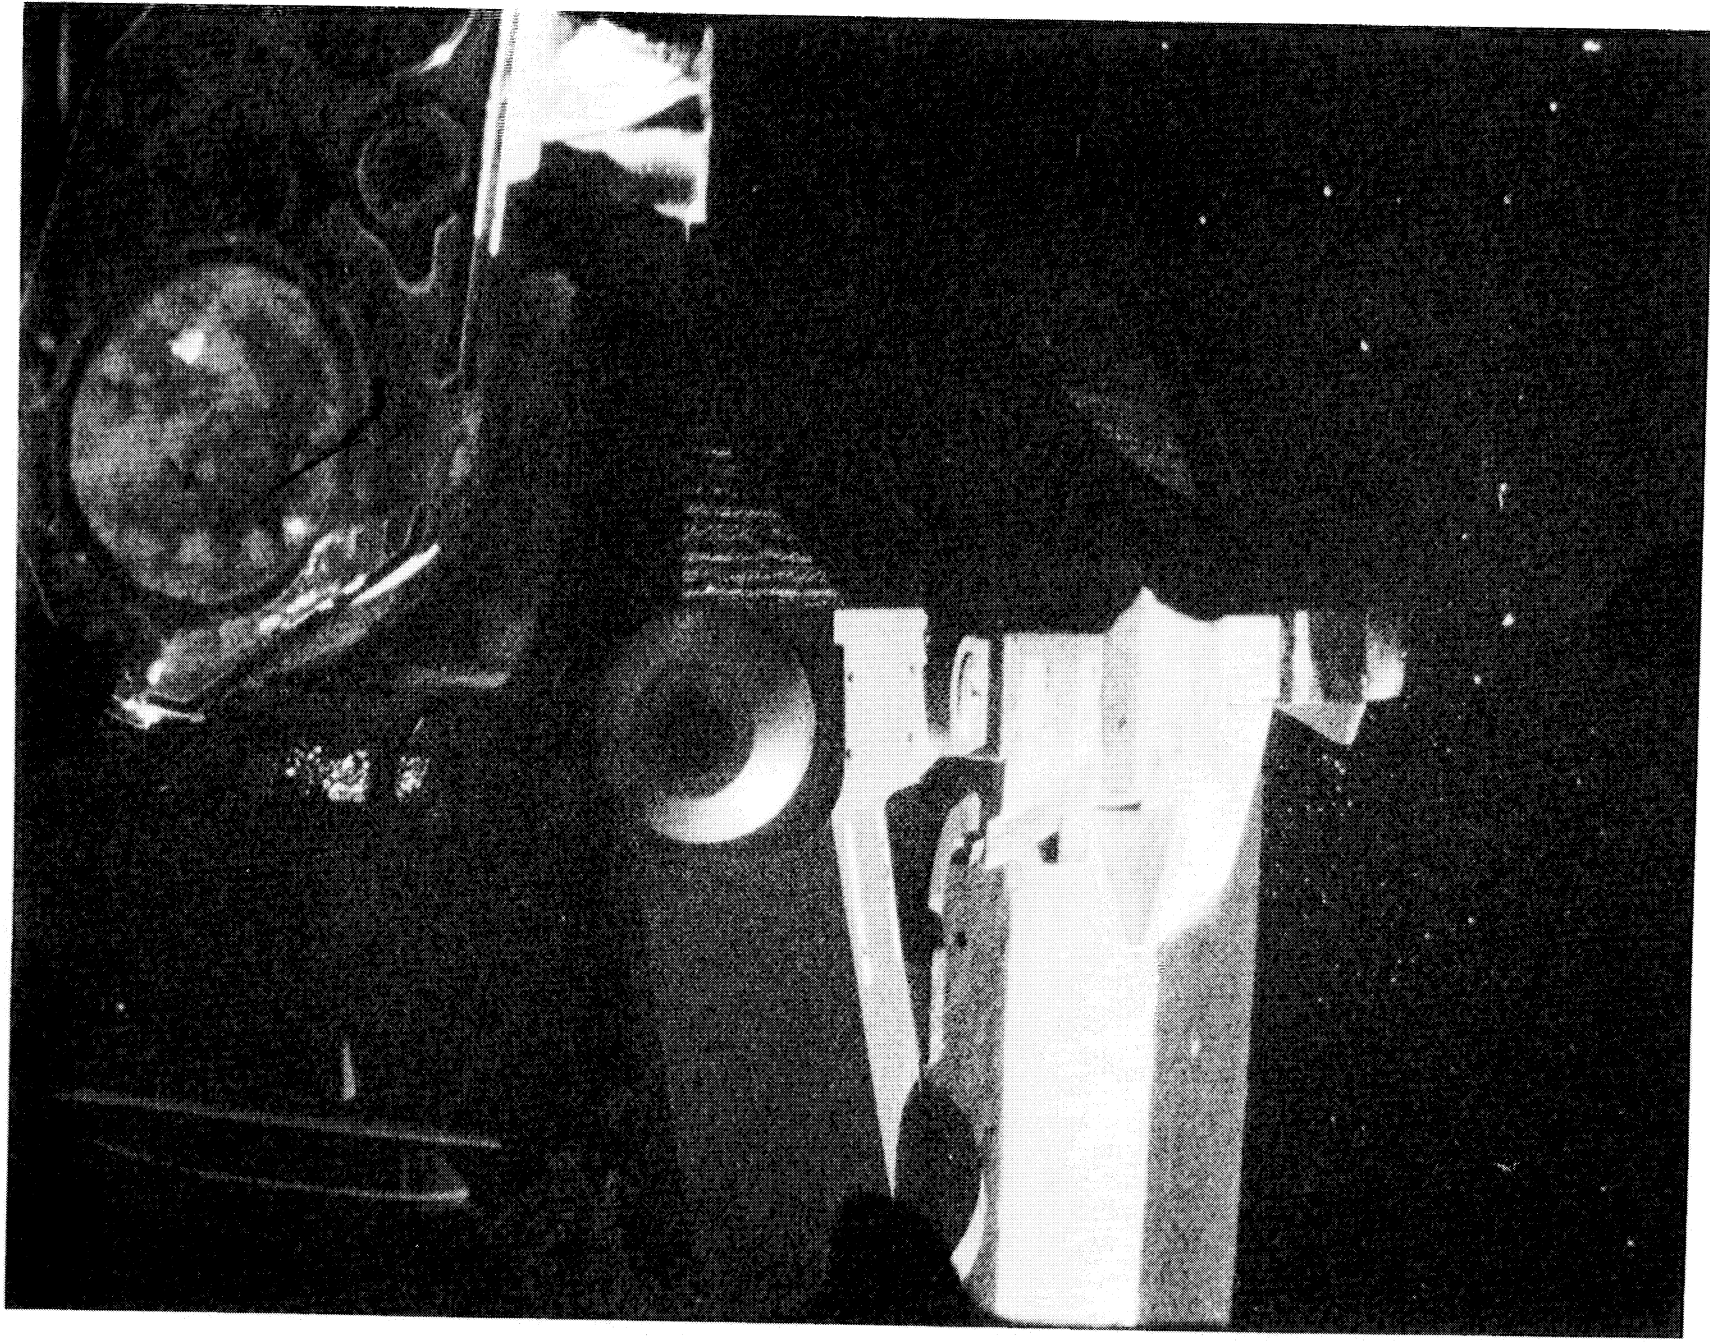
LH2 17-inch flapper valve is filled with frozen hydrogen. Top left area of umbilical is damaged/covered by frozen hydrogen.

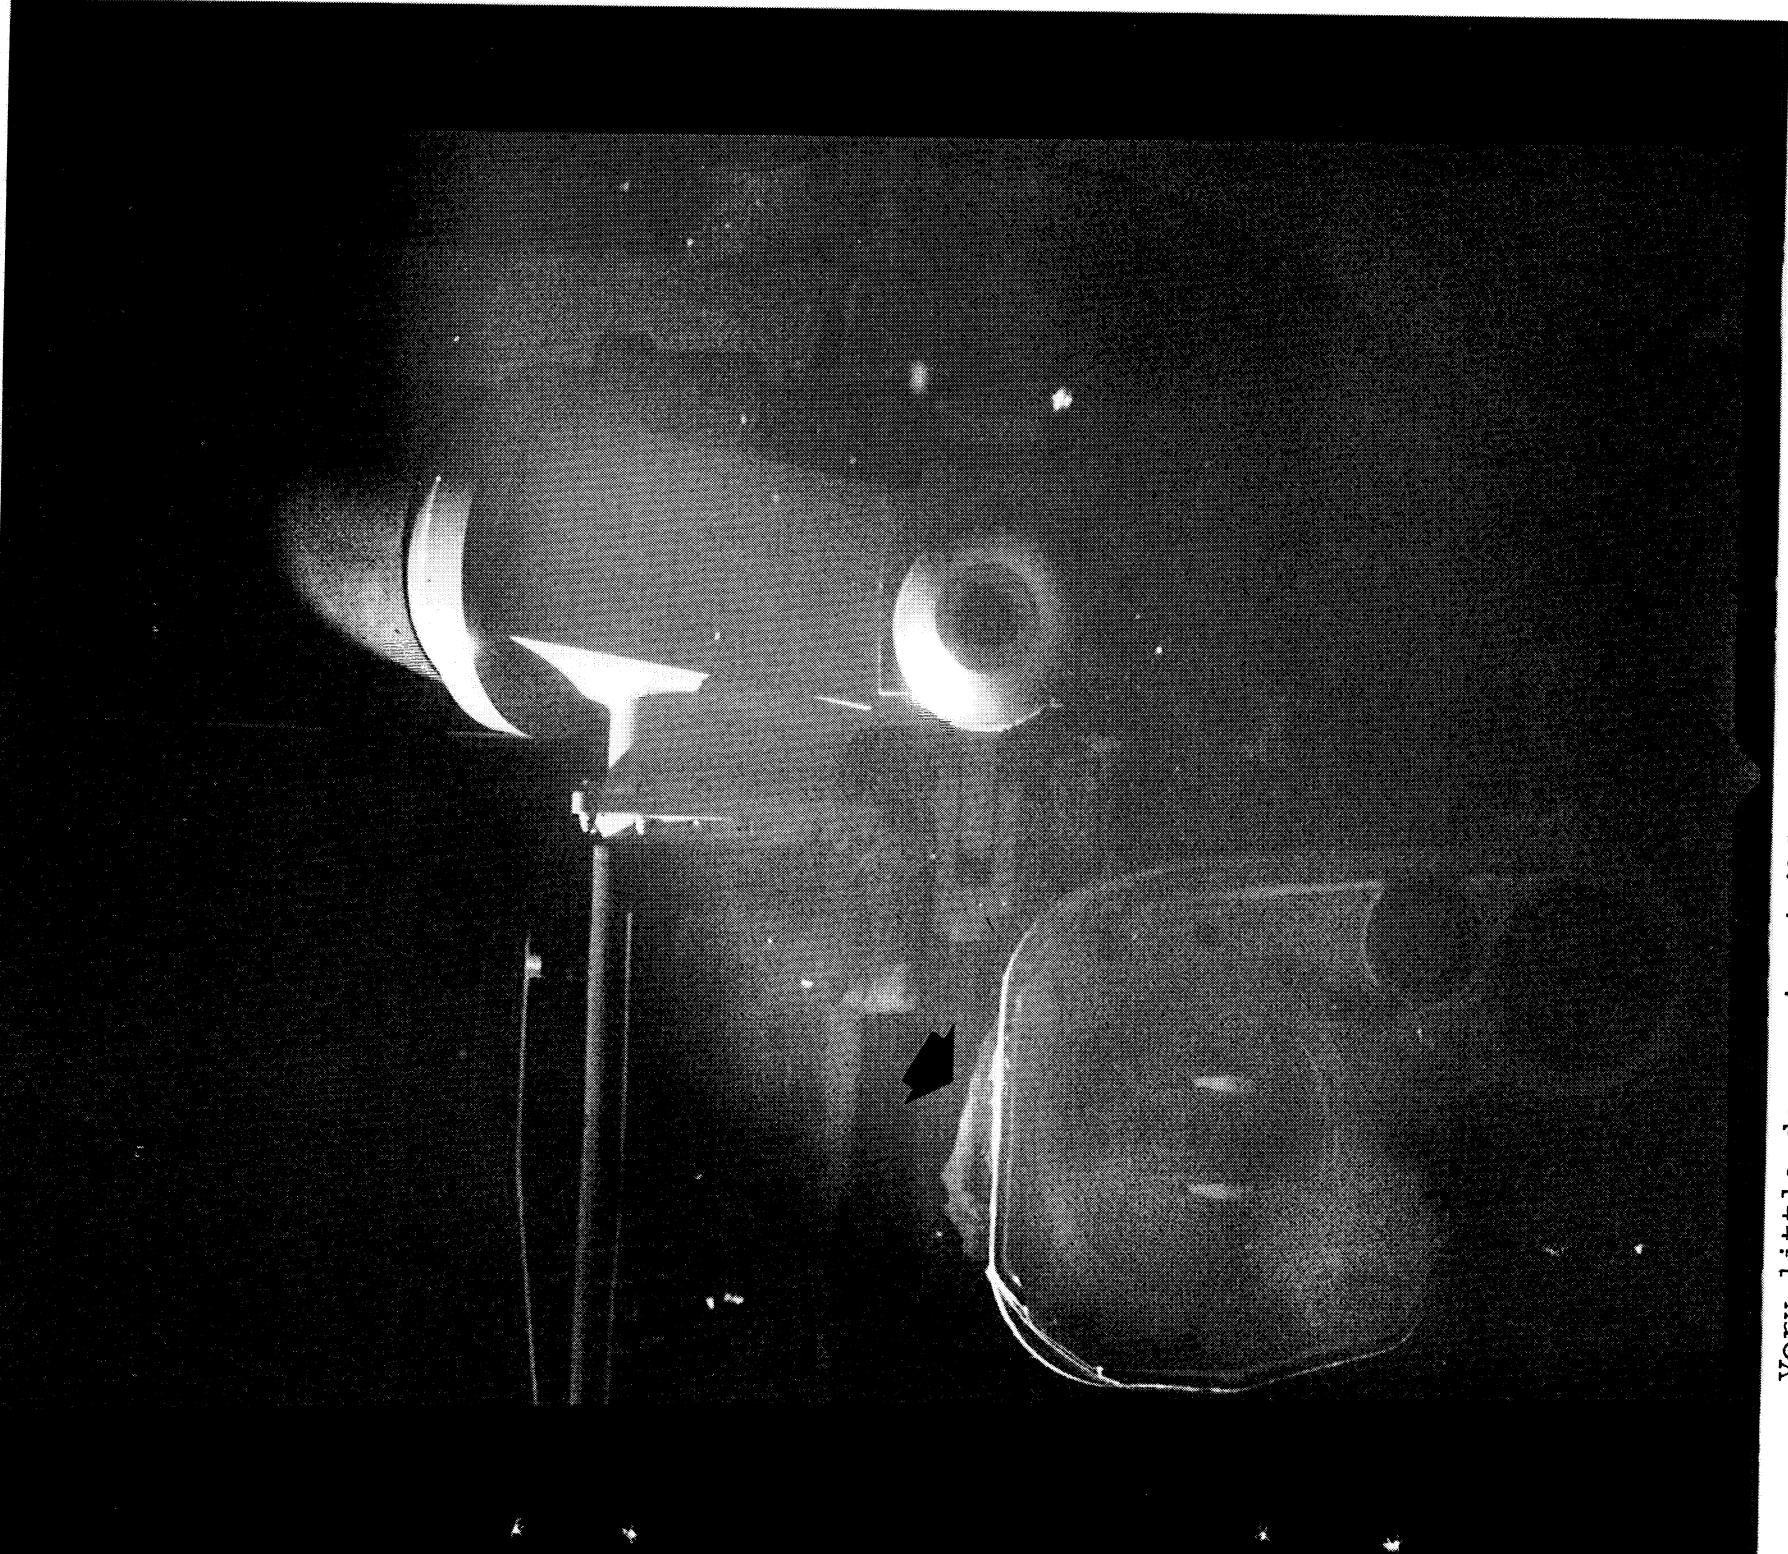
Very little damage is visible on +Y side of ET except for TPS  
peeled back or ice covering on top side of LO2 umbilical

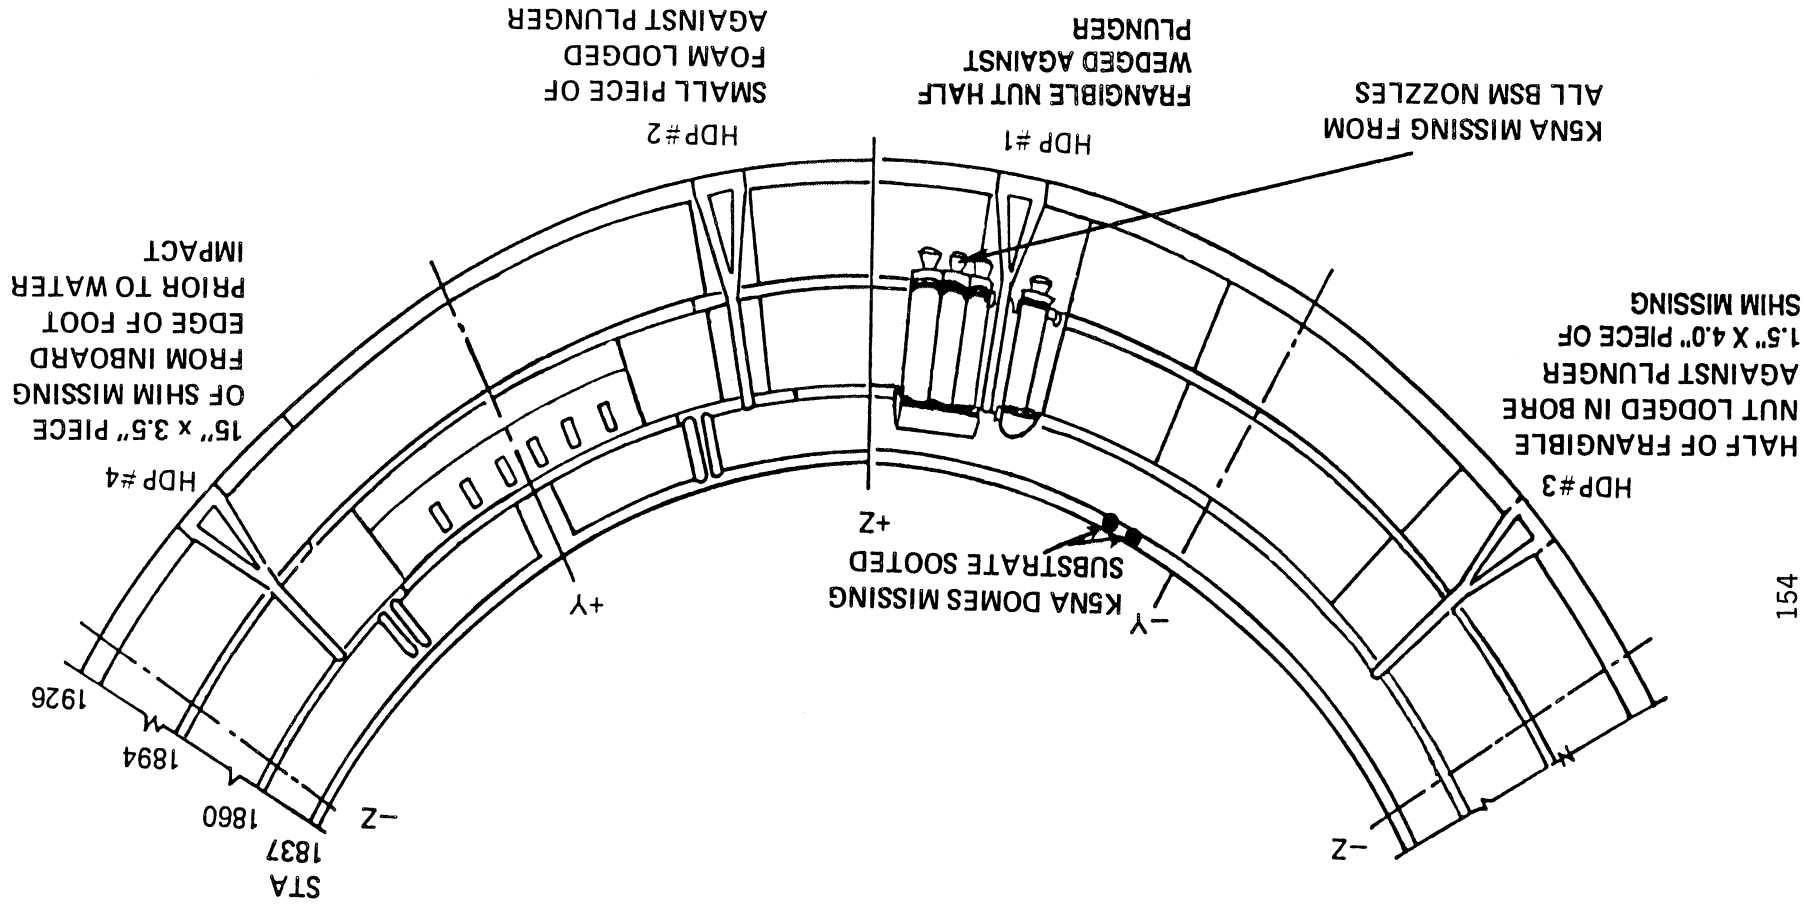
FIGURE 16. RIGHT SRB AFT SKIRT EXTERIOR TPS

The TPS over the aft skirt acreage was generally in good condition (Figure 16). The TVC system appeared to be undamaged. Instafoam was missing from the aft ring around the aft skirt feet, HPU exhaust horns, and joint heater umbilical.

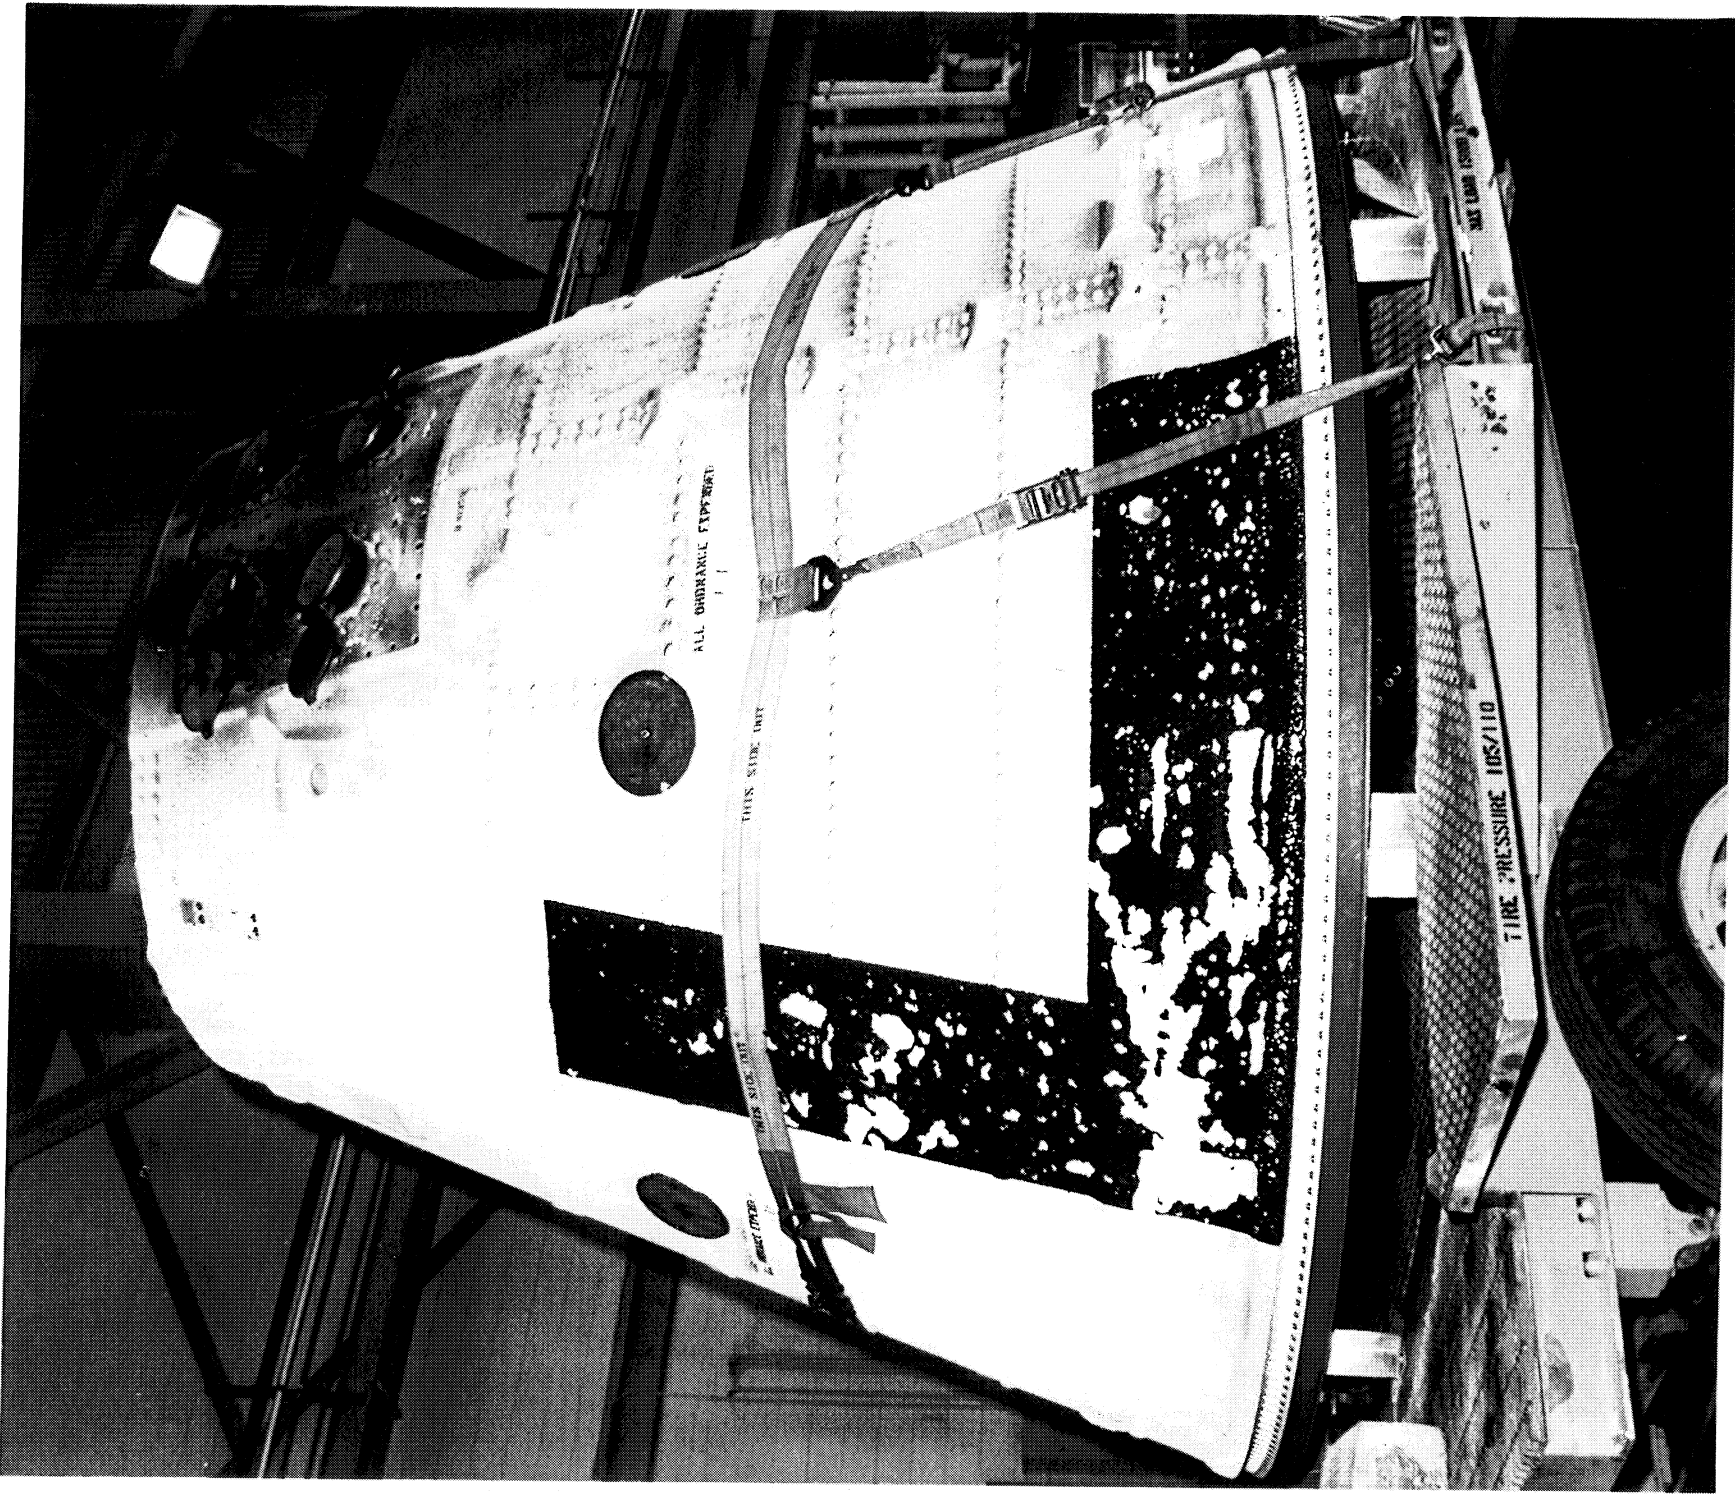
Overall view of RH frustum. Black Hypalon paint in visibility stripe has blistered and peeled away.

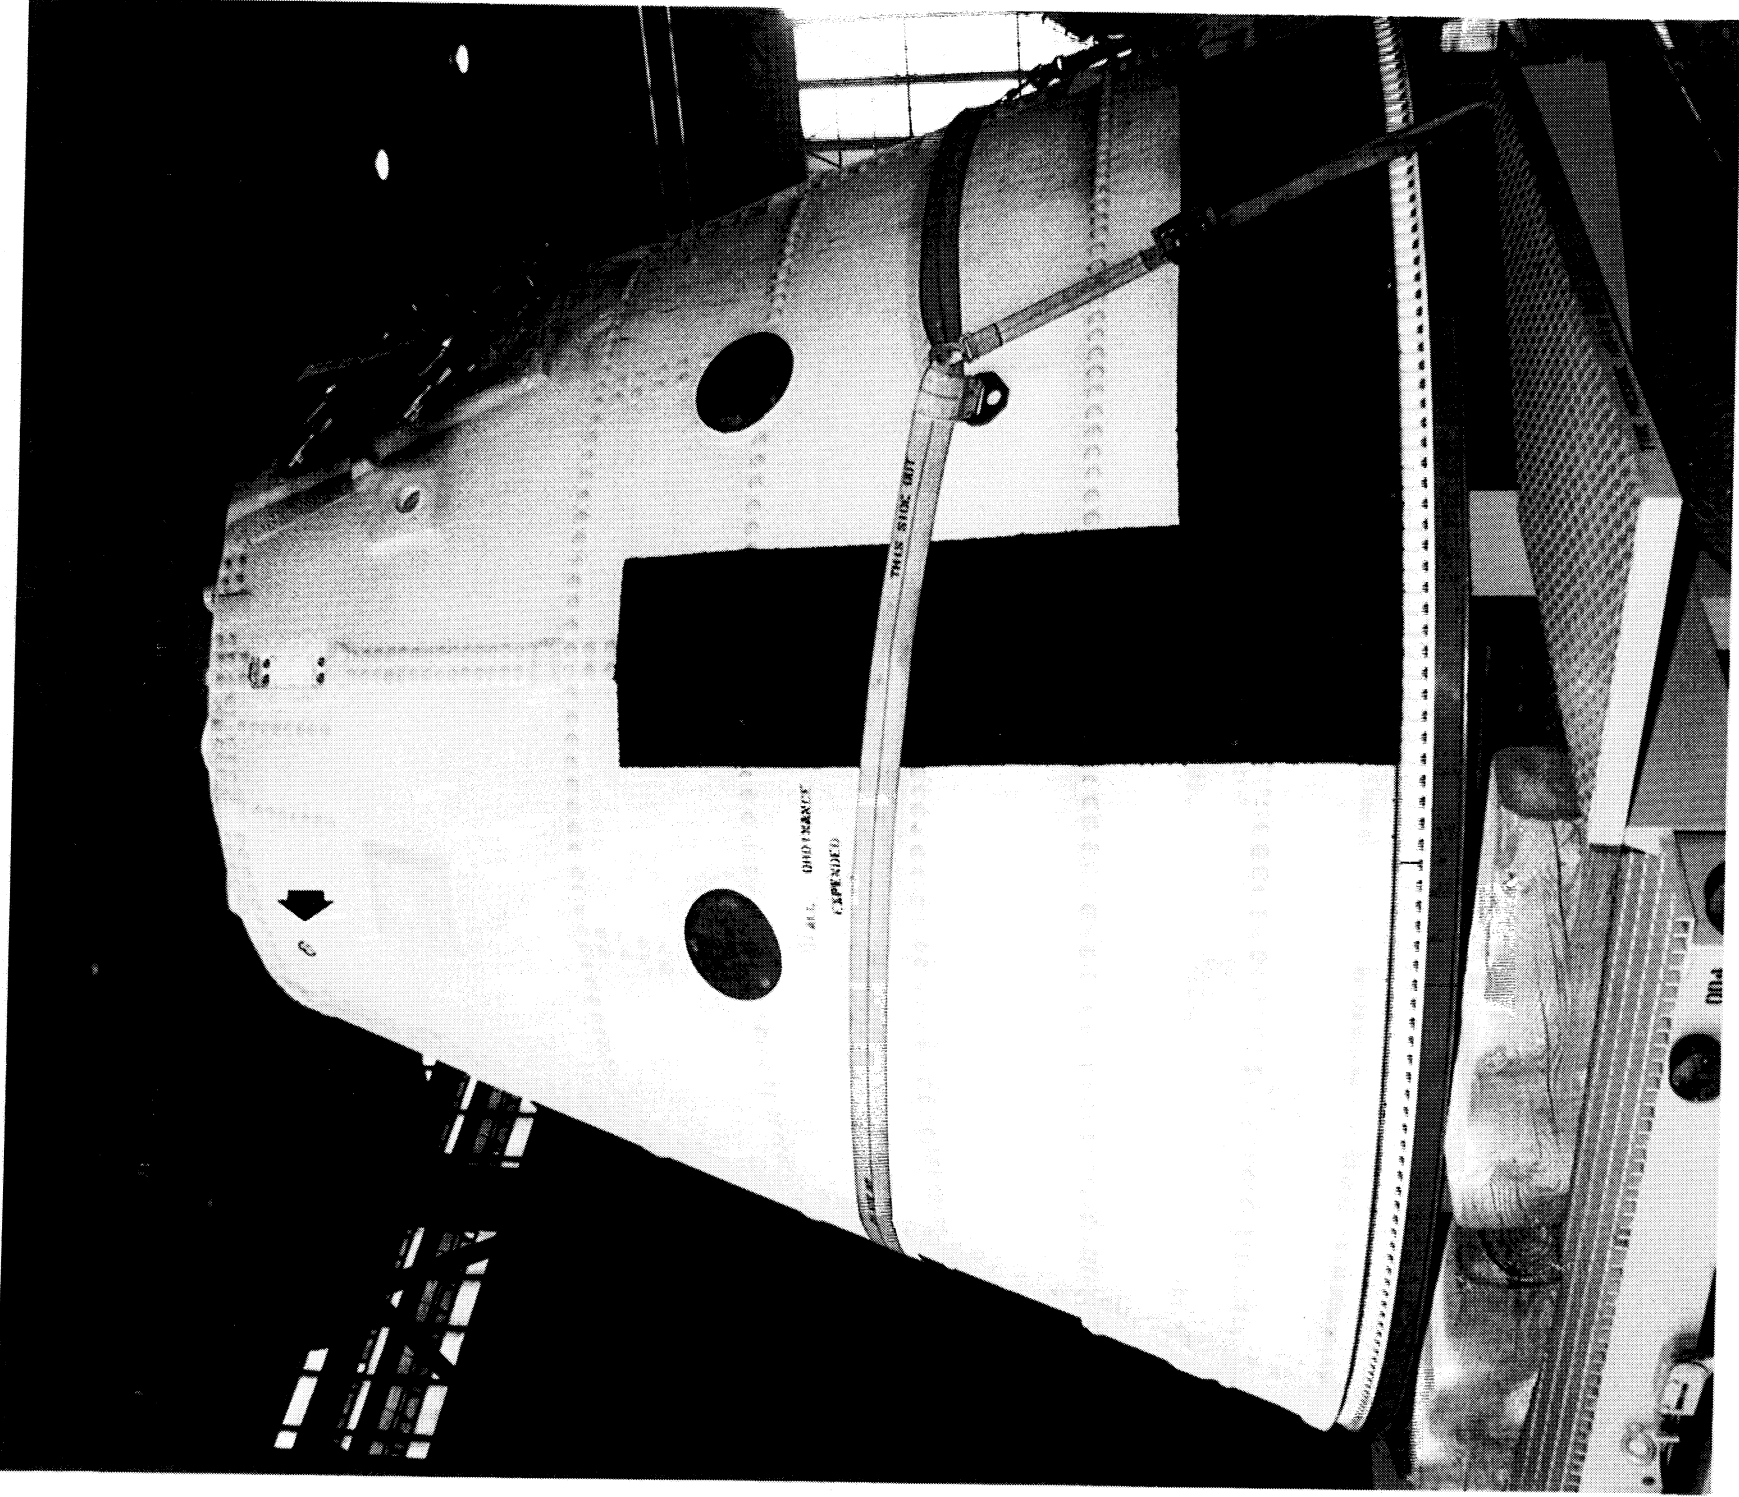
Overall view of LH frustum. A two inch diameter piece of MSA is missing from an area near the 275 ring.

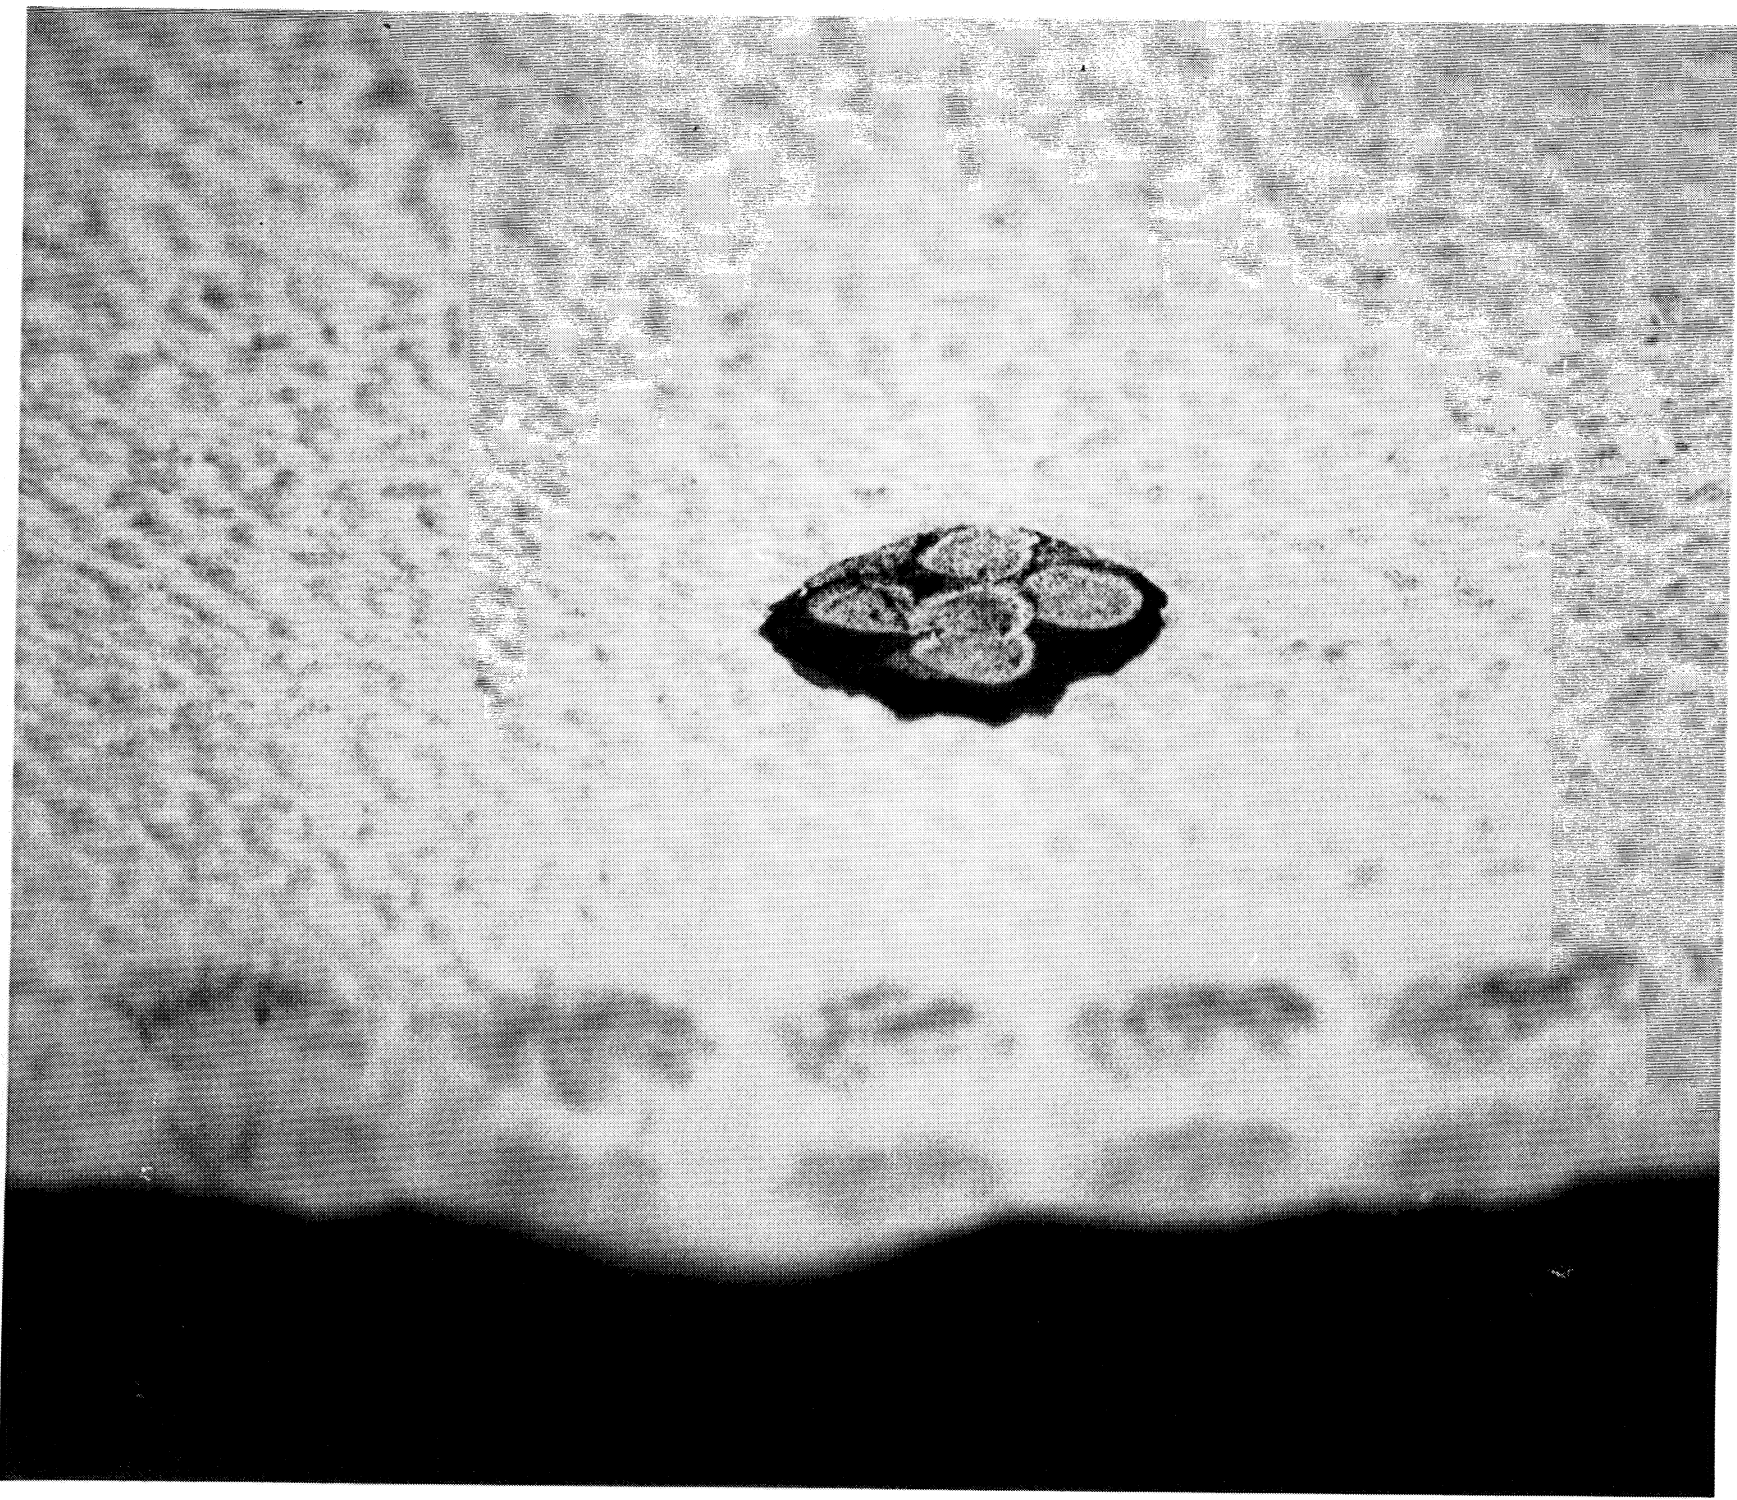
Close-in view of missing MSA near the 275 ring frame
